Inspection Report

Minerals Regulatory Program

Mine Name: Cane Creek Potash
Operator Name: Intrepid Potash

Permit number: M/019/005
Inspection Date: February 24, 2006
Time: 12:30-2:30 PM

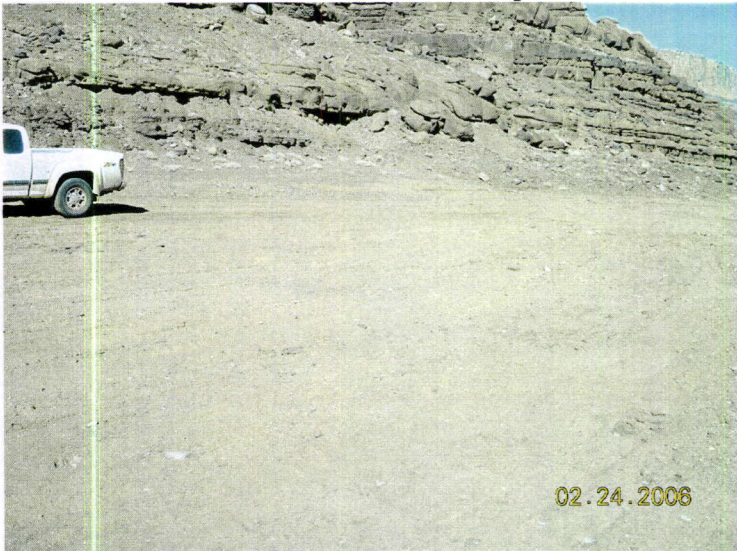
The first two test plots we visited (Photos 1 and 2) are the "soil ridging/furrowing vs. no soil ridging/furrowing test plots" as described on page 74 of the current edition of the mine plan. The intention is to see whether salts will concentrate on the soil ridges and furrows and allow plants to become established on the "slopes." The plots are both on salt-affected well pads that were graded and flushed with about 18000 gallons of water which, according to the plan, should be about one pore

The "no furrow" plot is very smooth, and I expect little to grow there, but one of the purposes of the test is to see whether furrows will increase vegetation establishment.

Photo 1. The "no furrow" test plot.

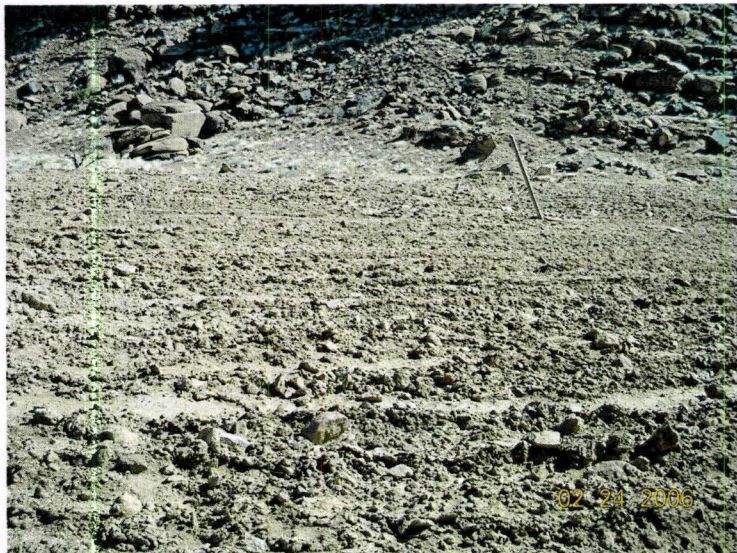
volume. The plot shown in Photo 2 was then furrowed, and both plots were seeded with a mix shown in the plan. We were able to find some of the seeds in both plots.

Photo 2. This test plot is designed to show whether salts can be isolated at the tops and bottoms of the furrows and allow plants to grow.

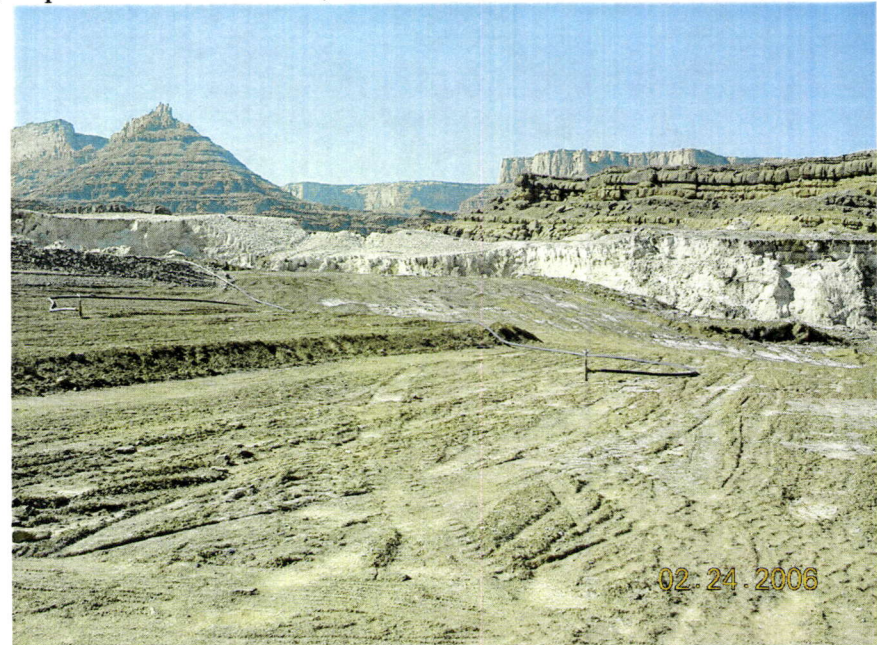
Two plots within the salt tailings pond area will be irrigated over an extended period (one or two years) in an attempt to leach salts from the soil. One of these plots is shown in Photo 3, and the other is adjacent to it on the left side of this photo. Irrigation has not yet begun on these plots.

Photo 3. These plots will be irrigated over the next one or two years to leach salts. They will then be seeded.

Immediately prior to seeding, the operator needs to roughen the surface of the plots that have yet to be seeded.

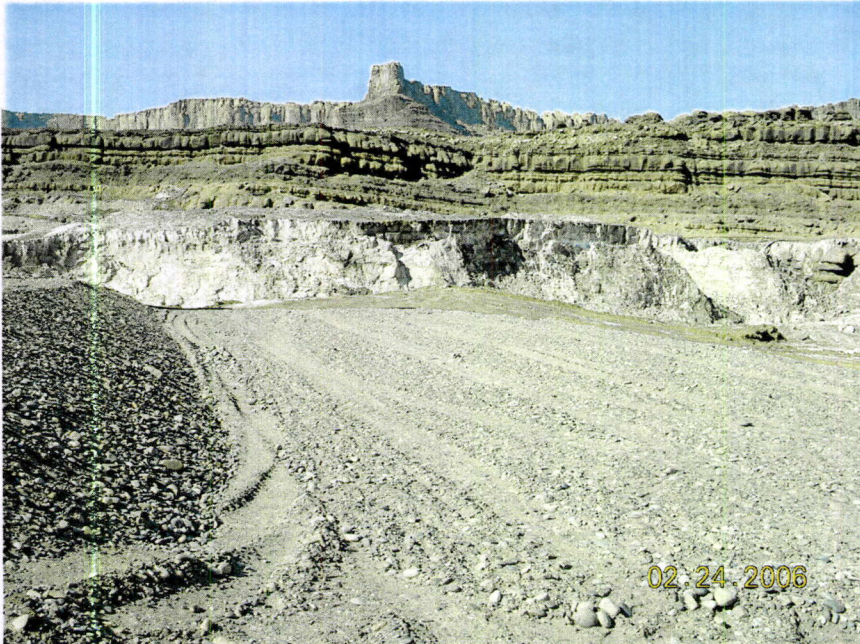
There are two additional plots in the salt tailings pond area, one of which is shown in Photo 4. These areas were covered with a perforated liner, then the liner was covered with 24 or 36 inches of alluvial soil. These areas were then seeded. The purpose of these test plots is to see whether 24 inches of soil is adequate for plants to become established and thrive or if more soil is needed. Some plants in this region have relatively shallow rooting depths while others have very deep roots, and the idea of the test plots is to see whether adequate vegetation can be established with limited soil

We were not able to find a lot of seed in the plots where alluvium was used for soil.

Although the plots with alluvium now look compacted, Mr. Klein assured me this was not the case when they were planted. If for some reason these plots need to be replanted, I recommend that the operator leave them rougher.

Because of the amount of rock in the plots where alluvium was used for soil, I do not believe they will have any erosion problems. The rock will also greatly increase infiltration.

Photo 4. This is one of two plots where a liner was placed over salt-affected soil followed by placement of alluvial soil. One plot received 24 inches of soil and the other had 36 inches.

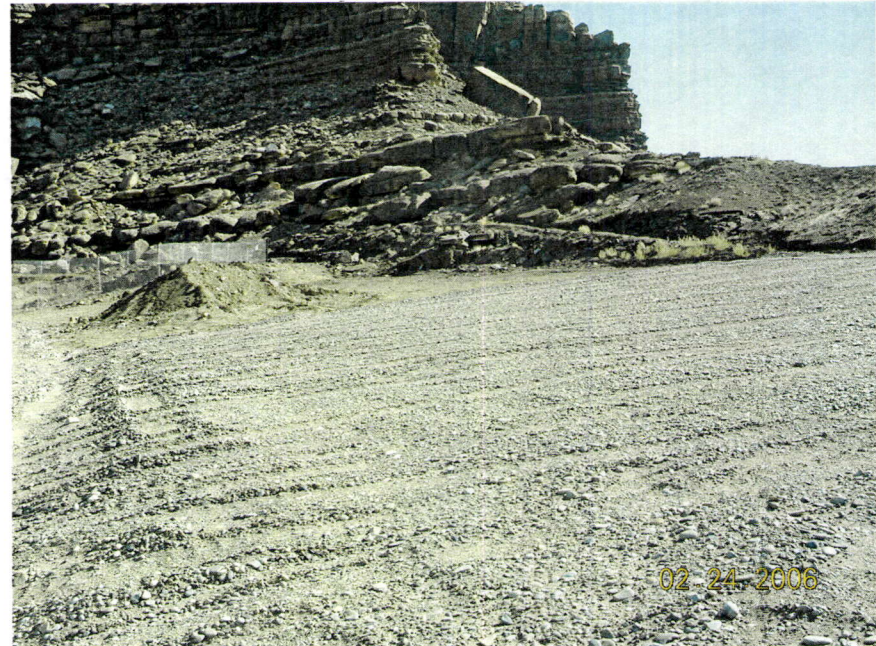
Photo 5 shows a control plot corresponding to the plots where a liner was used. Alluvial soil was placed over uncontaminated soil.

Photo 5. This is the control plot corresponding to the plots where soil was placed over liners. Alluvial soil was placed over uncontaminated soil. A portion of the new landfill is visible in the background.
